Durability of Galvanized Steel Framing for Residential Building

Summary of the seven-year Progress Report produced by NAHB Research Center, a subsidiary of the National Association of Home Builders (NAHB) in the U.S.A. and sponsored by International Zinc Association

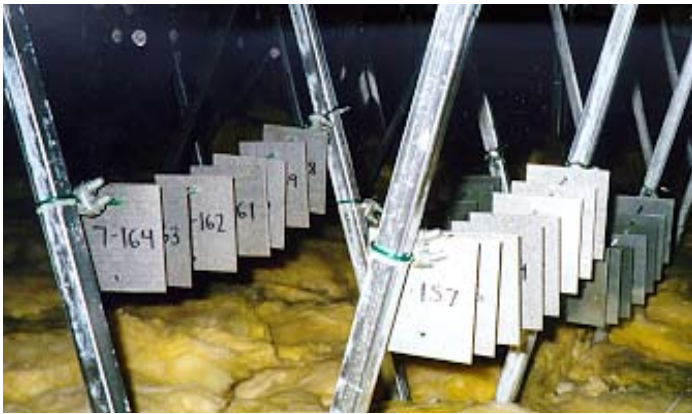
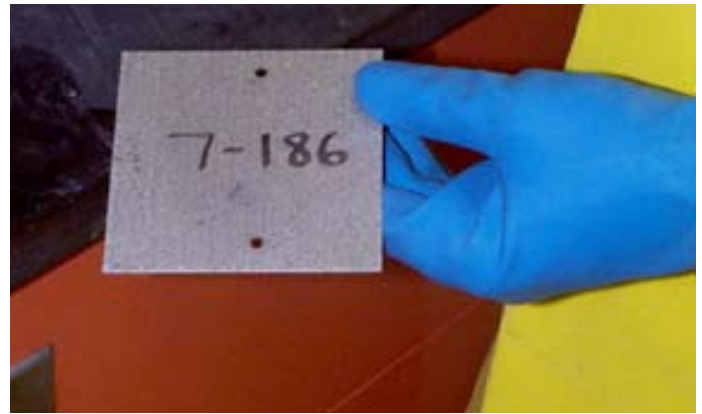
Figure 1 – Plate Samples

measure of coating corrosion rates calculated from mass reduction of the samples after exposure (Figure 1). The C-section samples were installed to investigate corrosion performance at the edges and bends of a stud. Both the plate and stud samples had both sides and all edges exposed. The coating thickness specifications for the samples are listed in Table

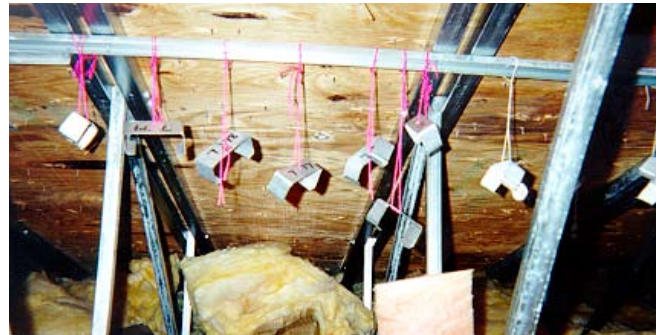
Sample colonies were located in both the attic (see Figure 3) and an exterior wall. The attic colony samples were suspended from the roof framing. The attic was vented by soffit vents on the east and west sides of the house.

Figure 3 - Attic Specimens in Miami, Florida Site

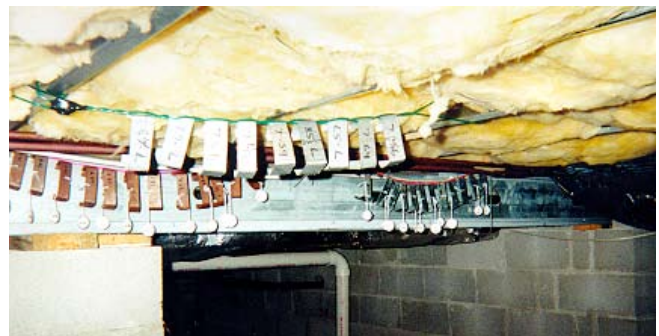
The crawlspace contained a set of suspended samples fully exposed to the ambient crawlspace environment, including bare (stripped) stud-type specimens. The bare samples displayed extensive corrosion after just two months of exposure, indicating the aggressive environment in the crawlspace (see Figure 5).

Figure 5 - Stud Specimen in Leonardtown Site Crawlspace

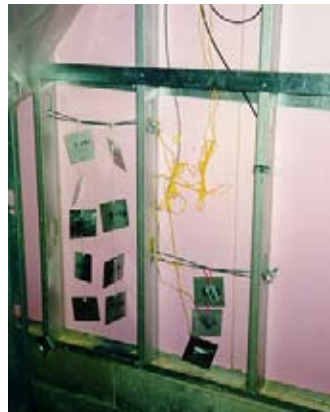
The attic samples were suspended in the air and thermistors were attached to one plate of each coating type to record the metal surface temperatures. The attic ambient temperature and relative humidity were also measured and a time of wetness sensor was mounted to a galvanized specimen to record the percentage of time that a moisture film was present. A similar installation was made in the exterior wall colony.

Figure 7 - Wall Cavity Specimens and Sensors in Hamilton, Ontario, Site
