Durability of Galvanized Steel Framing for Residential Building

Summary of the seven-year Progress Report produced by NAHB Research Center, a subsidiary of the National Association of Home Builders (NAHB) in the U.S.A. and sponsored by International Zinc Association

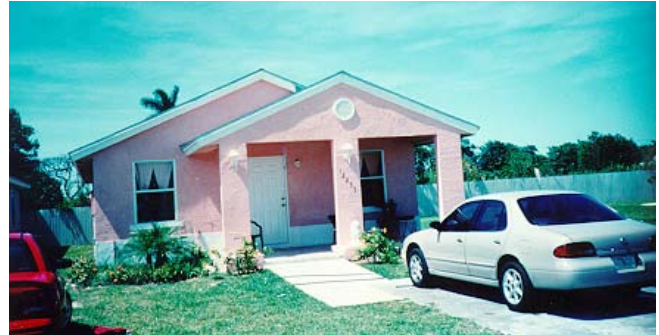
Figure 2 - Miami, Florida Corrosion Site

The Miami site (Figure 2) was in a Habitat for Humanity Development in southwest Miami, where 16 of the 90 homes were framed with steel systems. The site was a single-story steel framed structure with a slab foundation. It had plywood sheathing with a stucco exterior finish. The wall interior was 5/8 in. (16 mm) painted drywall. The attic was kraft faced (facing the drywall) fiberglass batts with an R-30, while the walls have either R-11 or R-13 batts. The walls were 6 in. (152 mm) wide. The attic was vented with soffit vents [19 vents total, each is 22 in. x 4 in. (56 cm x 20.5 cm)]. No ridge vents were present, and one small gable end vent was visible in the front of the house.

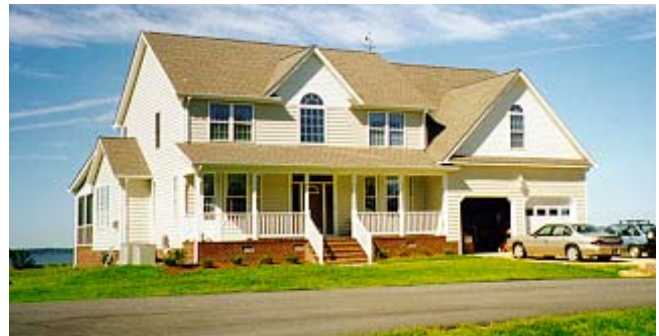
Figure 4 - Leonardtown, Maryland, Site on Lower Potomac River

The Leonardtown, Maryland, house (Figure 4) was directly on the lower Potomac River before it empties into the Chesapeake Bay. The two-story home was roughly 75 feet (23 m) from the river, with strong winds often blowing spray towards the house from the brackish river water. The walls were framed with 0.043 in. (1.1 mm) thick steel C-section studs, while steel trusses were used for the roof framing. Steel floor joists were used in the crawlspace along with R-19 fiberglass batts. A layer of poly was installed on the crawlspace floor. The attic was insulated with 11 in. (28 cm) of blown cellulose and vented with a ridge vent and soffit vents. The walls consisted of 5/8 in. (16 mm) drywall, wet-blown cellulose (R-13), OSB sheathing, 1 in. (25 mm) of non-foil faced foam cladding (R-5), a Tyvek air infiltration barrier, and vinyl siding. The only notable interior moisture source is a large Jacuzzi tub in the master bathroom. All bathrooms were vented directly to the outside. The foundation was vented with perimeter vents in the block wall.

Specimens were installed under the outdoor deck, which represented an extreme worst-case environment. The deck was boldly exposed to any river spray, and was actually framed with wood. The sample

colony under the decking provided performance data in an extremely aggressive environment. Corrosion results from this test site were found to be similar to the corrosion rates observed for the crawlspace colonies.

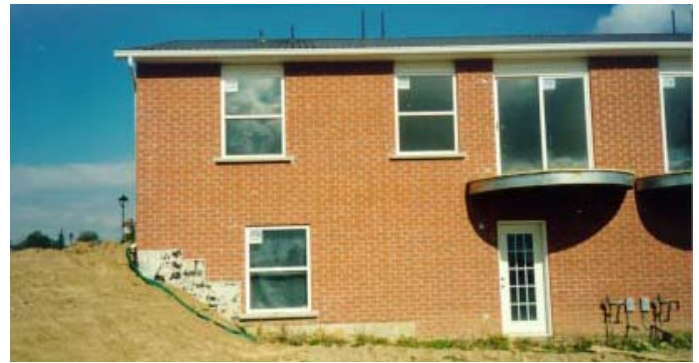
Figure 6 - Hamilton, Ontario Test Site (Rear View)

The Hamilton, Ontario, site (Figures 6 and 7) was a single-story house in a retirement community. It was the end unit, with a walk-out basement. Three of the four basement walls were concrete block, with the fourth wall (east facing) being steel-framed. The framed walls were designed as follows: interior wall covering was 5/8 in. (15 mm) drywall, behind which a poly vapor barrier was installed. The walls were insulated with R-13 fiberglass batts. Beyond the framing was 1-1/4 in. (32 mm) of foam sheathing (R-7). Outside of the foam sheathing was a 1 in. (25.4 mm) air gap, with a brick veneer finish beyond this.

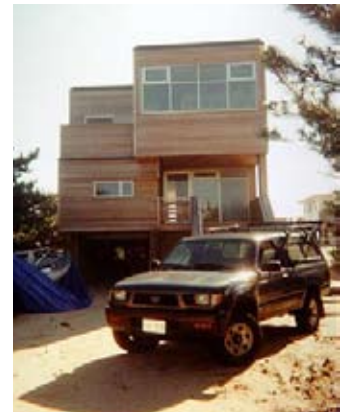
Figure 8 - New Jersey Site

The Long Beach Island, New Jersey site (Figure 8) was the last addition to the research study with specimens being installed in 1998. The site was a beachfront house on the New Jersey shore, and was separated from the ocean by a low-lying dune roughly 1/4 mile (400 m) wide. The house was originally a one-story structure, and was remodeled to include a new second floor and roof that were both framed with cold-formed steel (Figure 9). The house was occupied primarily during the summer season, and was left vacant during the winter.

Three sample colonies were established in the New Jersey site. The first was a full set of stud and plate samples located between the joists that supported the first story. This location should carry some risk of corrosive conditions because it was not immune to infiltration air and outdoor conditions. The second colony was located on a cantilevered deck that

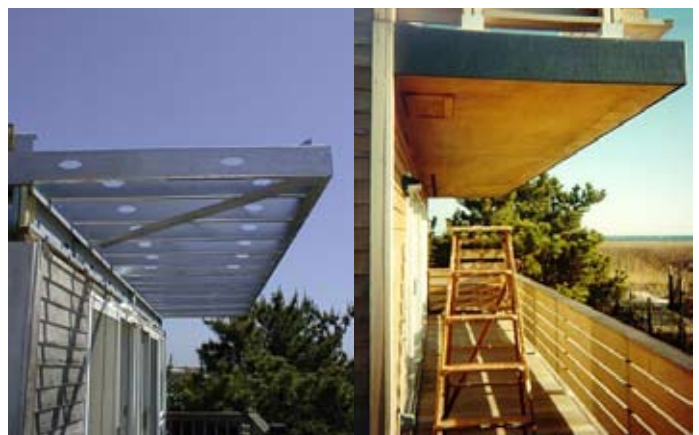
Figure 9 - New Jersey Site Under Construction

hung off the second story of the home and faced the beach (Figure 9). The joist bays under the deck were vented, which presented an opportunity for ocean breezes to deposit salt and/or moisture on the samples. The third colony was in a steel-framed exterior wall on the second floor.
